RIVANNA RIVER STEWARD REPORT

Date: 6/5/18

Starting Location and Time: Advanced Mills Bridge (4 PM) NF Rivanna

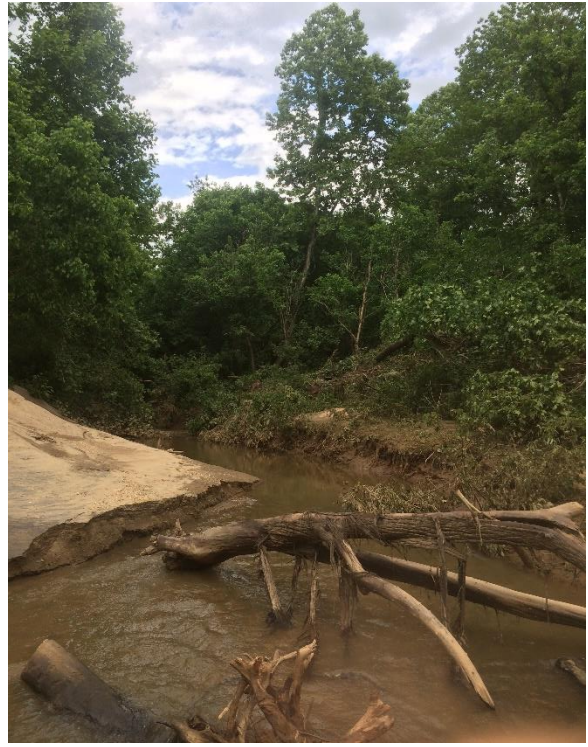
The devastation of the recent flooding was ever present along the way. It could be viewed that the water reached over 20 feet high above the banks of the River. Many large trees had been uprooted and intertwined together along the banks. Much of the vegetation on many banks had been wiped out and will cause increased erosion during any future heavy rain events the rest of this summer until revegetation can occur. All of the feeder streams along the way were observed as being severely eroded leading into the North Fork Rivanna River.

Figure 2: Eroded feeder stream, Marsh Run.

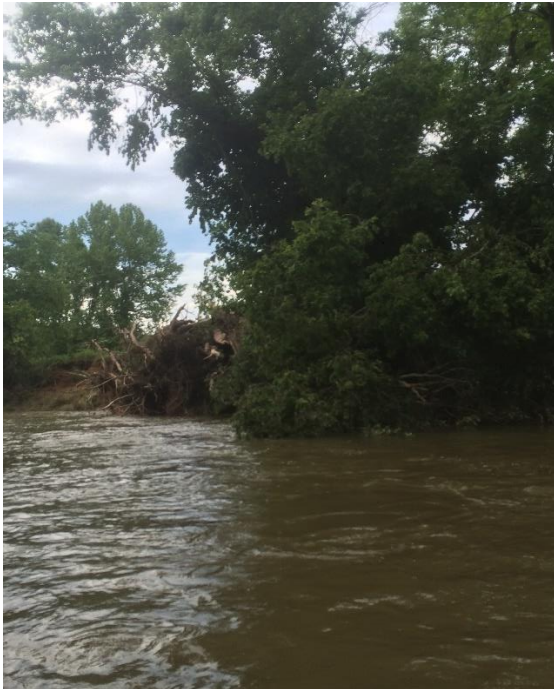
Figure 3: Entangled tree roots along bank.

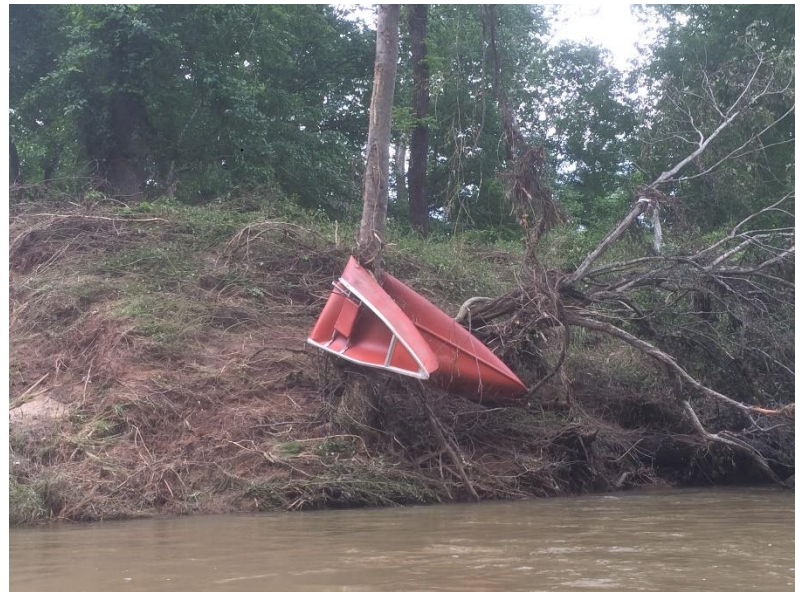
Figure 4: A canoe that got washed away & wrapped around a tree during flooding.

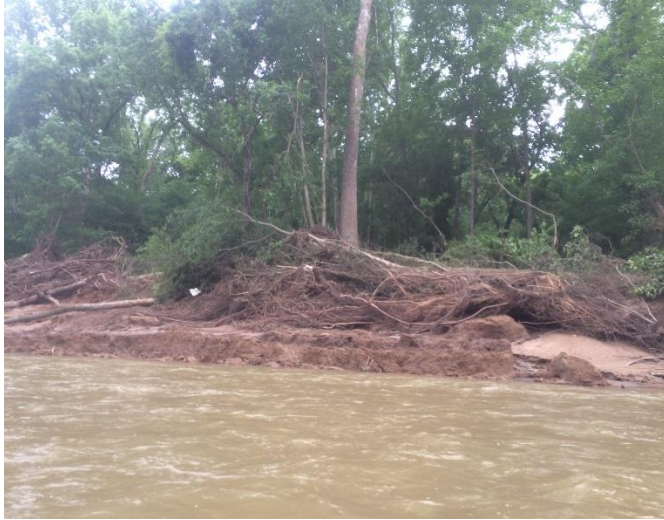
Figure 5: Flood damaged River banks.

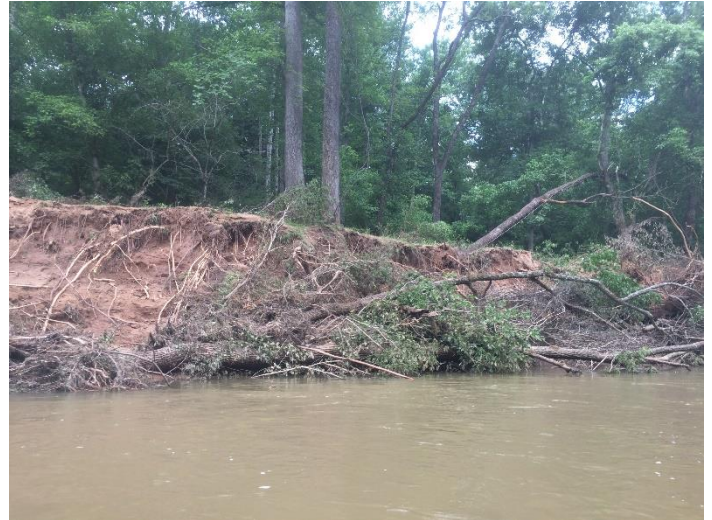
Figure 6: Trees damaged in flood.

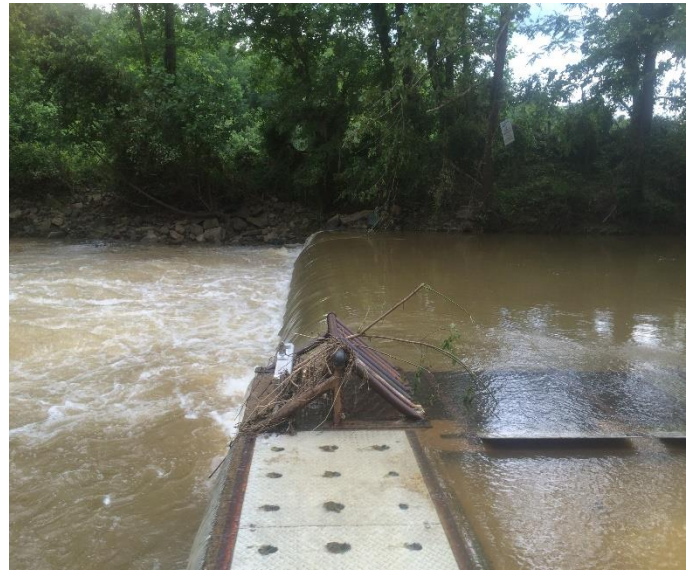
The area where the RWSA water treatment facility is located contains a small dam that requires portage out of the River. This area was eroded to the point that accessing the other side of the River after the dam was difficult.

Figure 10: Dam requiring portage at RWSA facility.

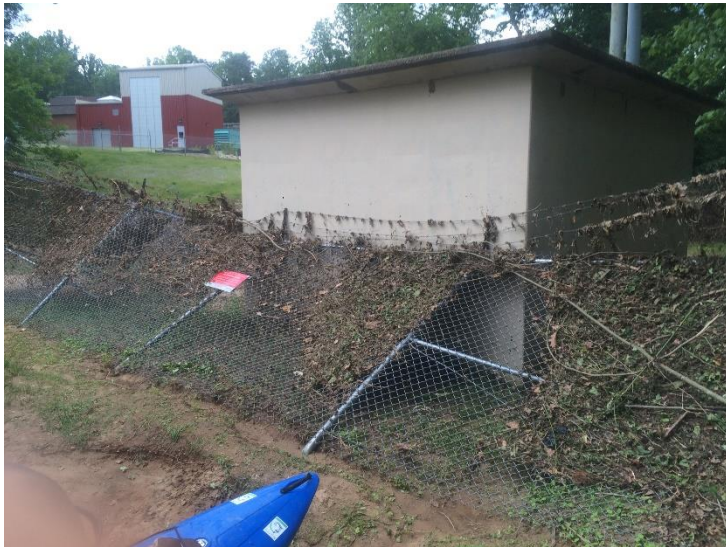
Figure 11: Flooding damage at RWSA facility.

3 – contact RWSA to inquire about any site work they plan to undertake adjacent to the River to remediate flood damage areas

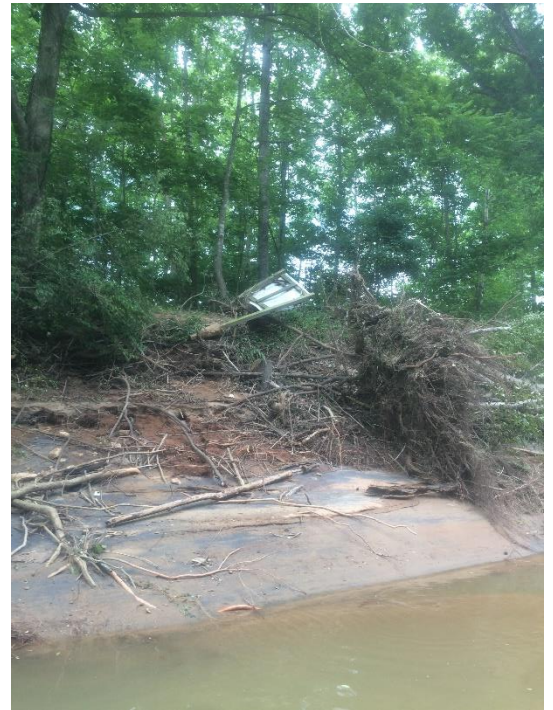
Figure 12: Severely eroded banks to navigate after porting around RWSA dam.
